NATIONAL COAL BOARD

Face Delay Study. 3rd South Moss.

Report No. *310/3/66*

*Mr W. Stephens*DUST SUPPRESSION DEPARTMENTCHATTERLEY WHITFIELD COLLIERY - 1's SOUTH HARDMINEINTRODUCTION:

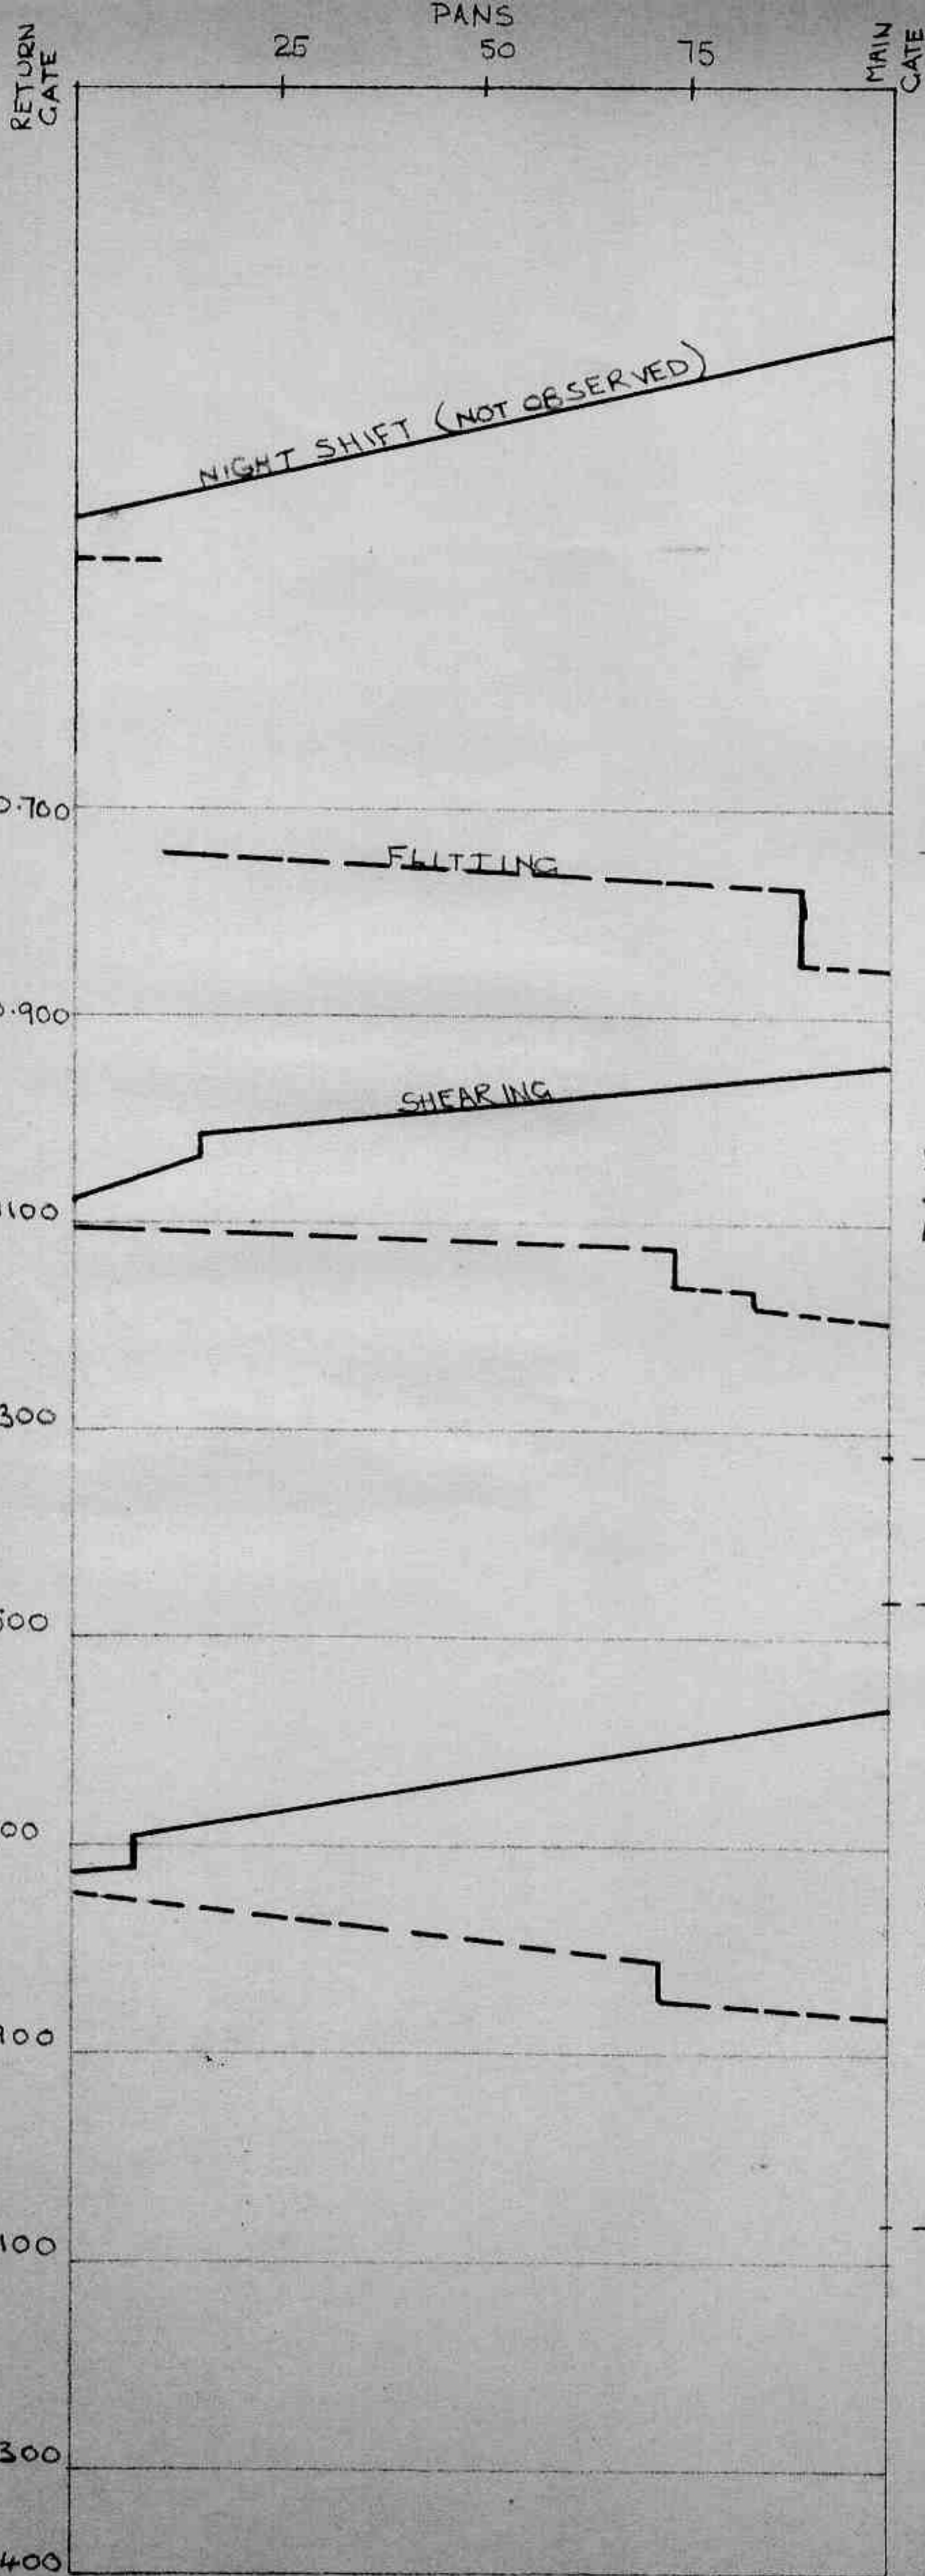
TUESDAY 8/2/66

RECORDED DELAYS (MINS)			
COAL CLEARANCE	STOWING	TIMBERING	OTHERS
		51.6	
			31.0
			9.6
21.0			9.9
		74.0	
		38.0	3.2
			29.2
			7.7
	98.0

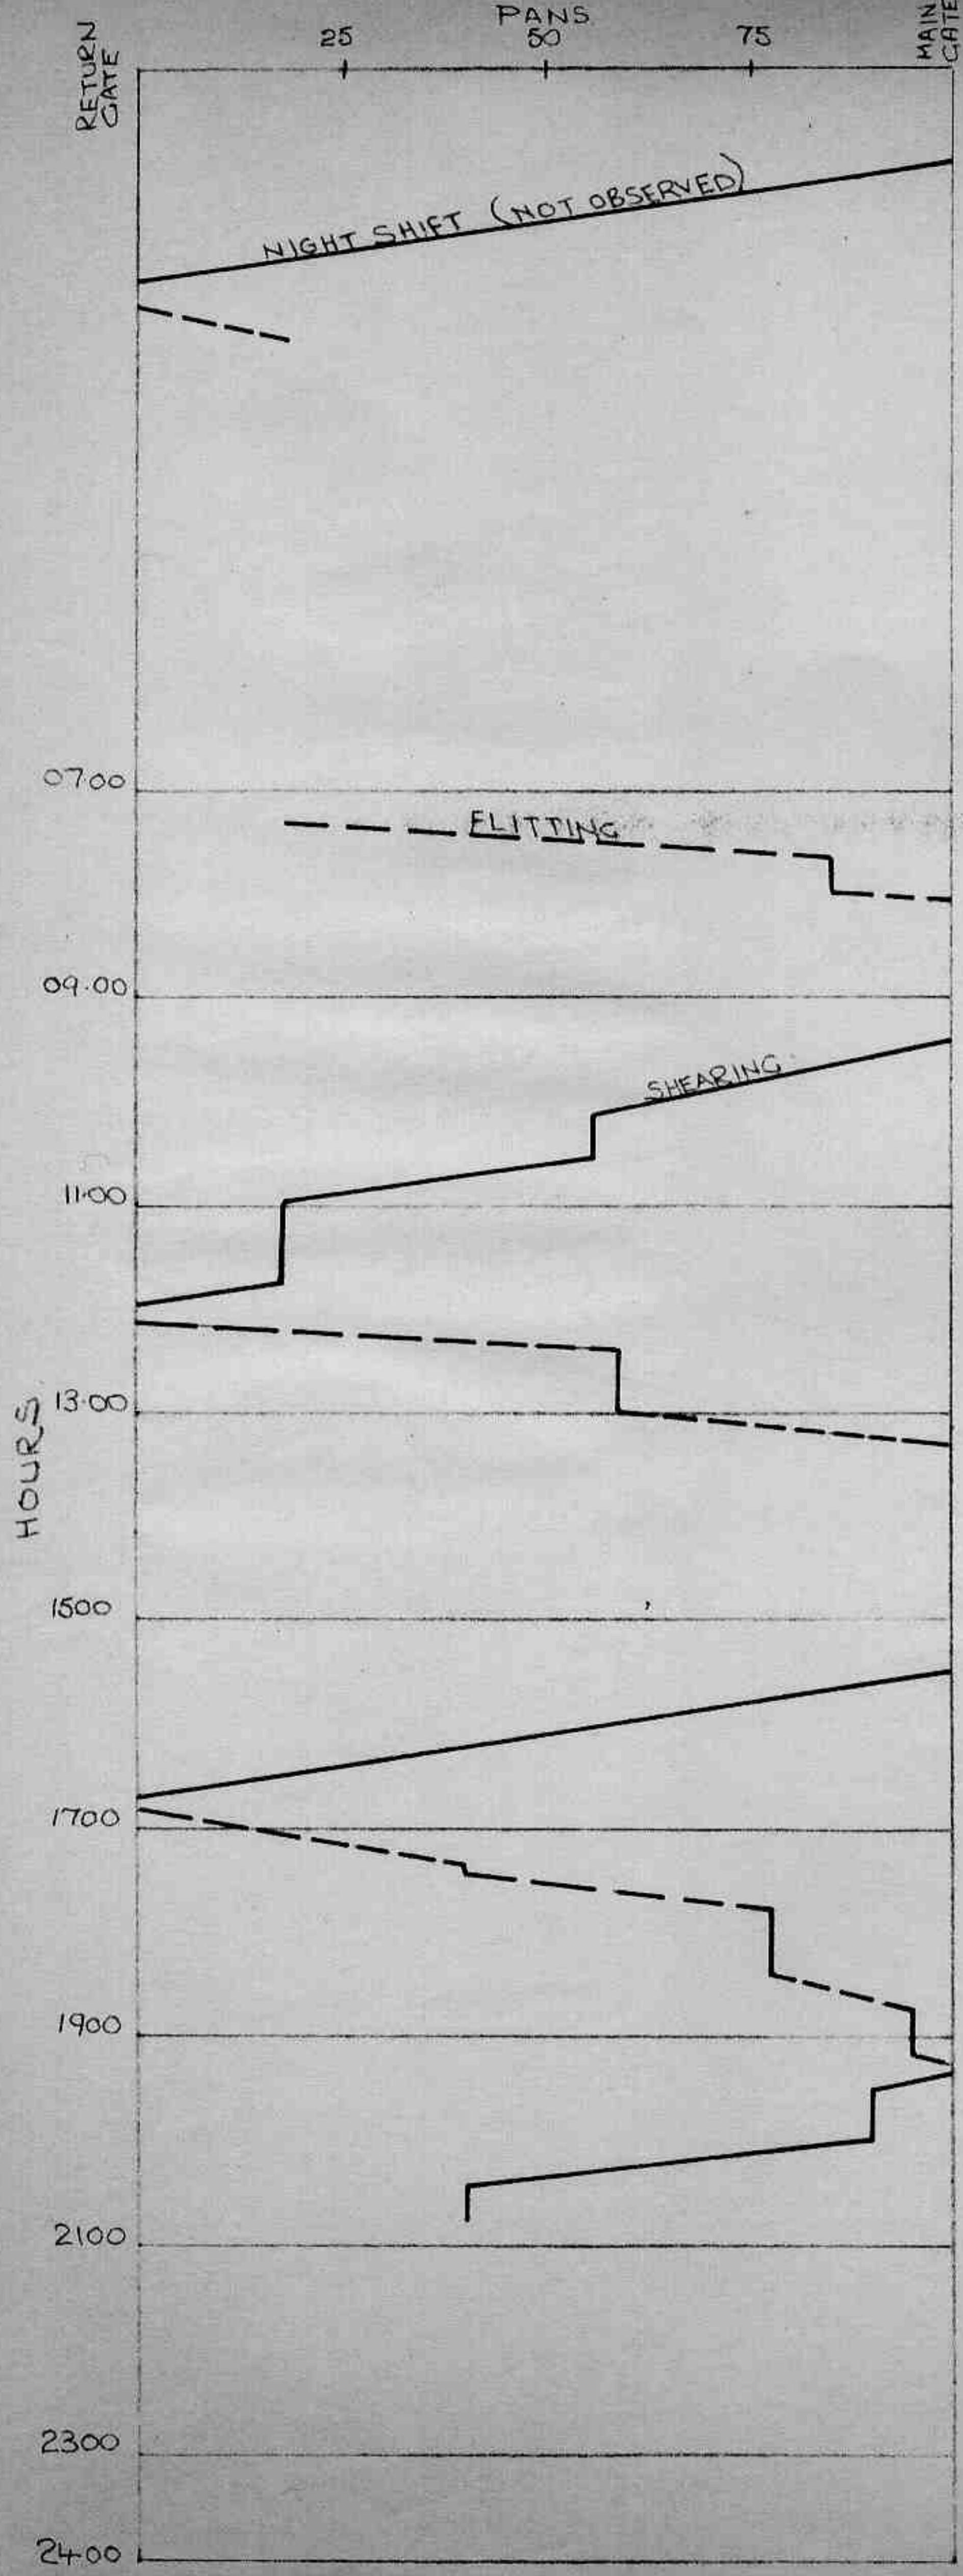
WEDNESDAY 9/2/66

RECORDED DELAYS (MINS)			
COAL CLEARANCE	STOWING	TIMBERING	OTHERS
		19.5	2.0
		62.0	
49.5			27.9
38.2			0.9
		23.0	
	1.05		7.58
45.5			47.2
29.5			1.60

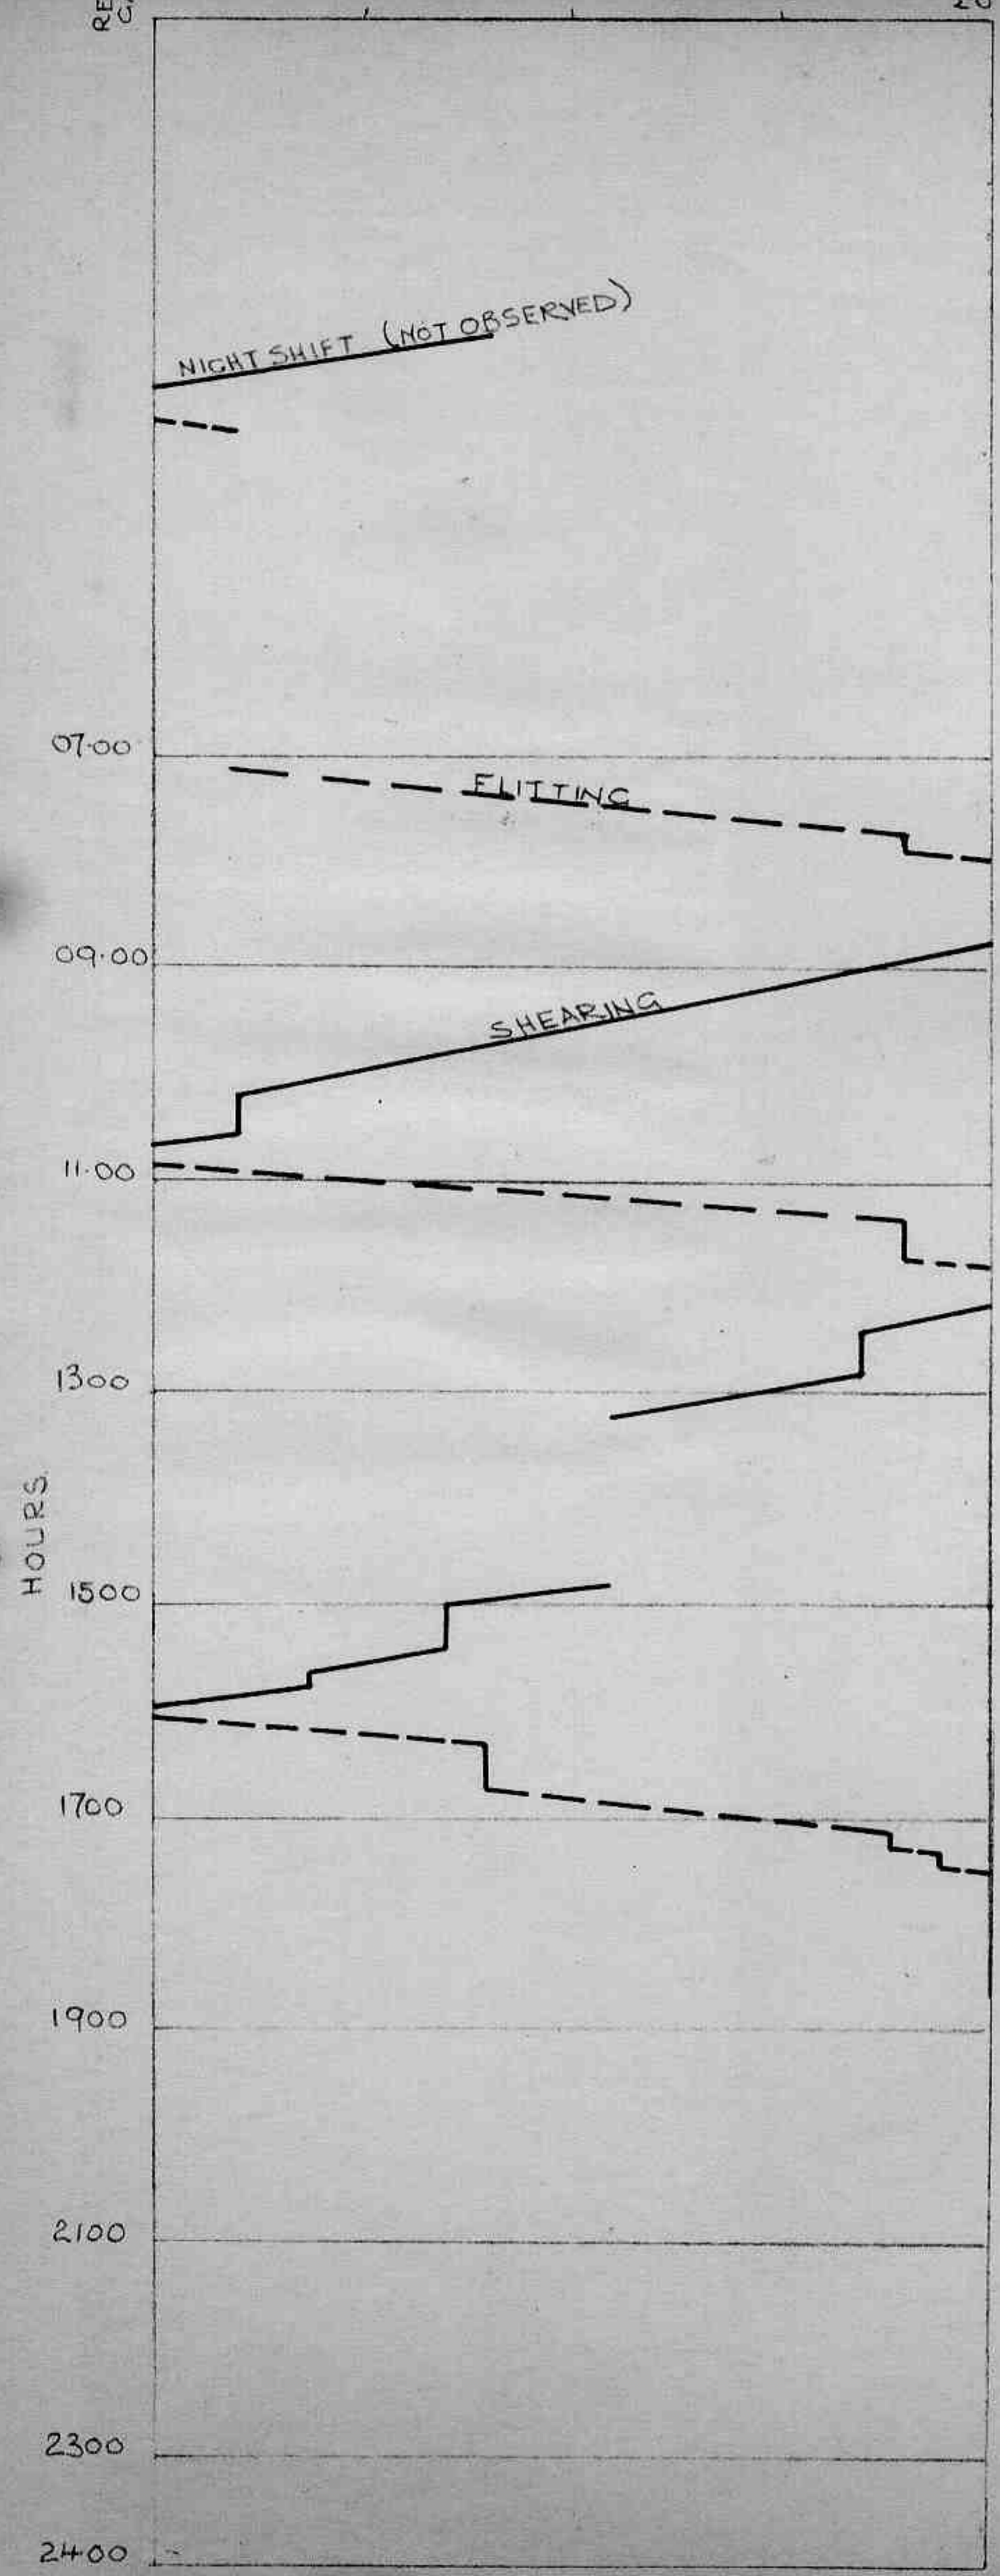
THURSDAY 10/2/66

RECORDED DELAYS (MINS)			
COAL CLEARANCE	STOWING	TIMBERING	OTHERS
		11.0	
	40.0		
			21.1
-	-	-	-
16.3			8.2
		11.0	
23.0			3.1
-	-	-	-
23.3			9.3
-	-	-	-
22.5			30.5
	162.0

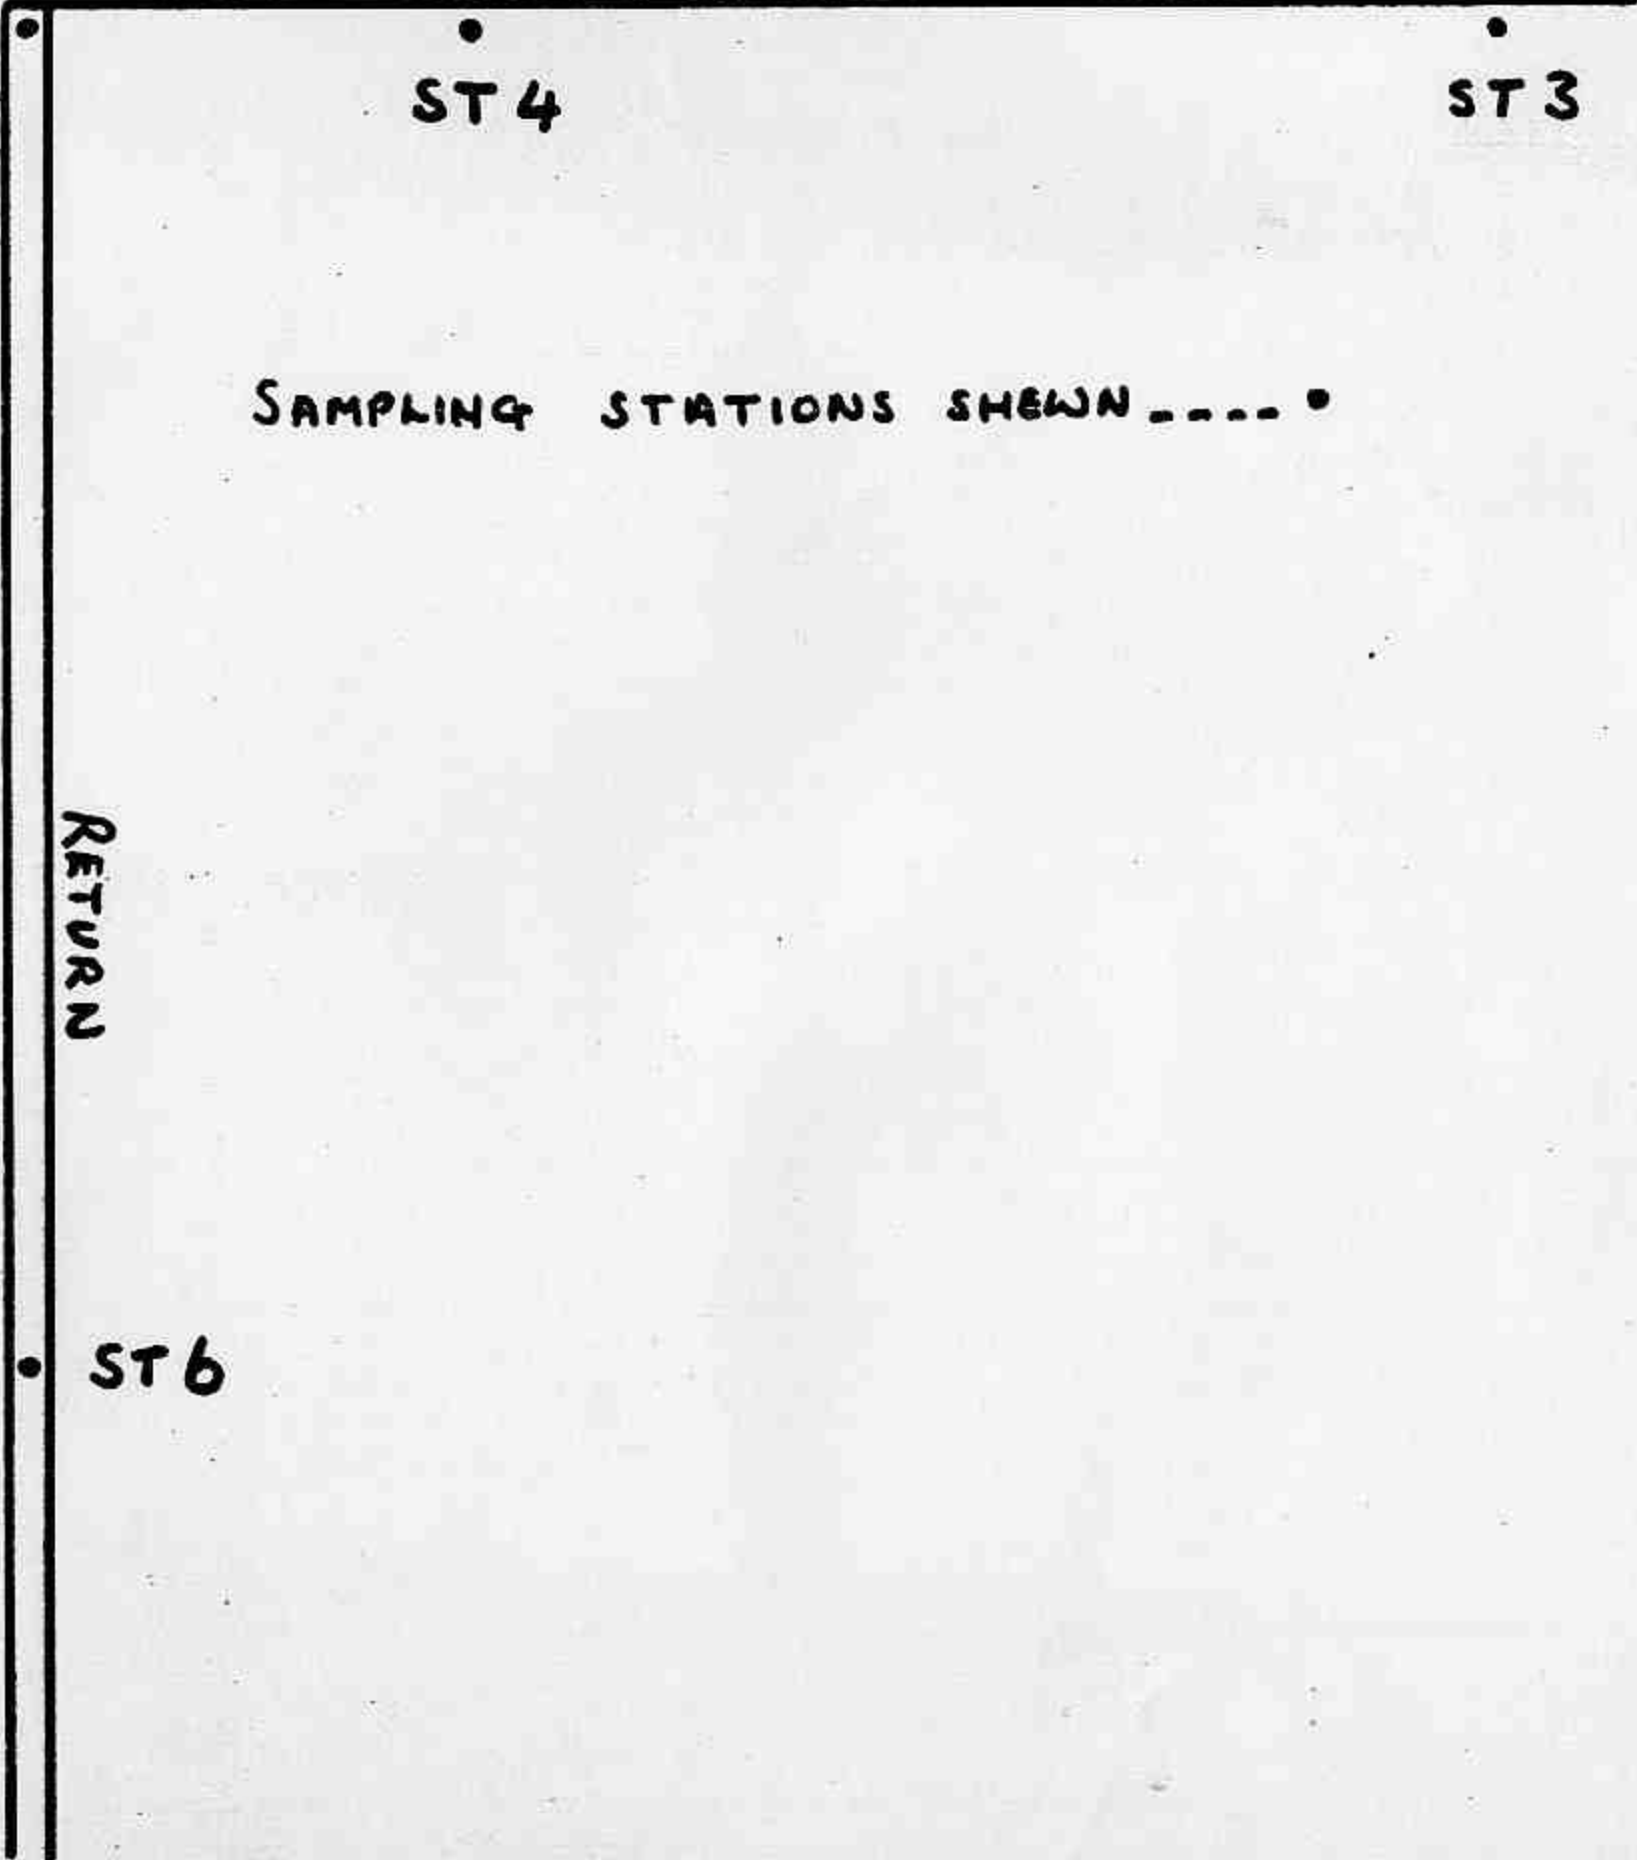
AIRBOURNE DUST SURVEY

The average dust concentration at the 70 metre mark in the intake is 4.1 mg/m³.

The two headings in front of the face at the intake end, contribute about 3 mg/m³ of dust so that the air starting up the face has a dust load of 6.7 mg/m³.

The main shearer which is automatically steered and the other operations along that length of face contribute about 5 mg/m³.

There is a further pick up of about 1 to 2 mg/m³ from the main machine finishing point out to the 70 metre point in the return airway.

Action should be taken to reduce the intake pollution from 4.1 mg/m³ to 2 mg/m³. The methods are outlined in a document already in the hands of the Colliery Dust Suppression Officer.

The ventilation system for the two advanced headings has no filter system and immediate improvement can be obtained by placing a Joy Microdyne free standing filter over the stage loader adjacent to the face. There should be at least 8 to 10,000 c.f.m. of air filtered to improve the face intake to below 3 mg/m³.

The shearer should have a new drum with wider pick spacing and the facility for a hollow shaft ventilator.

All rippings should be bored wet and the dirt piles must be regularly wetted. ✓

A significant improvement would result if the air quantity could be increased by at least 50%. ✓

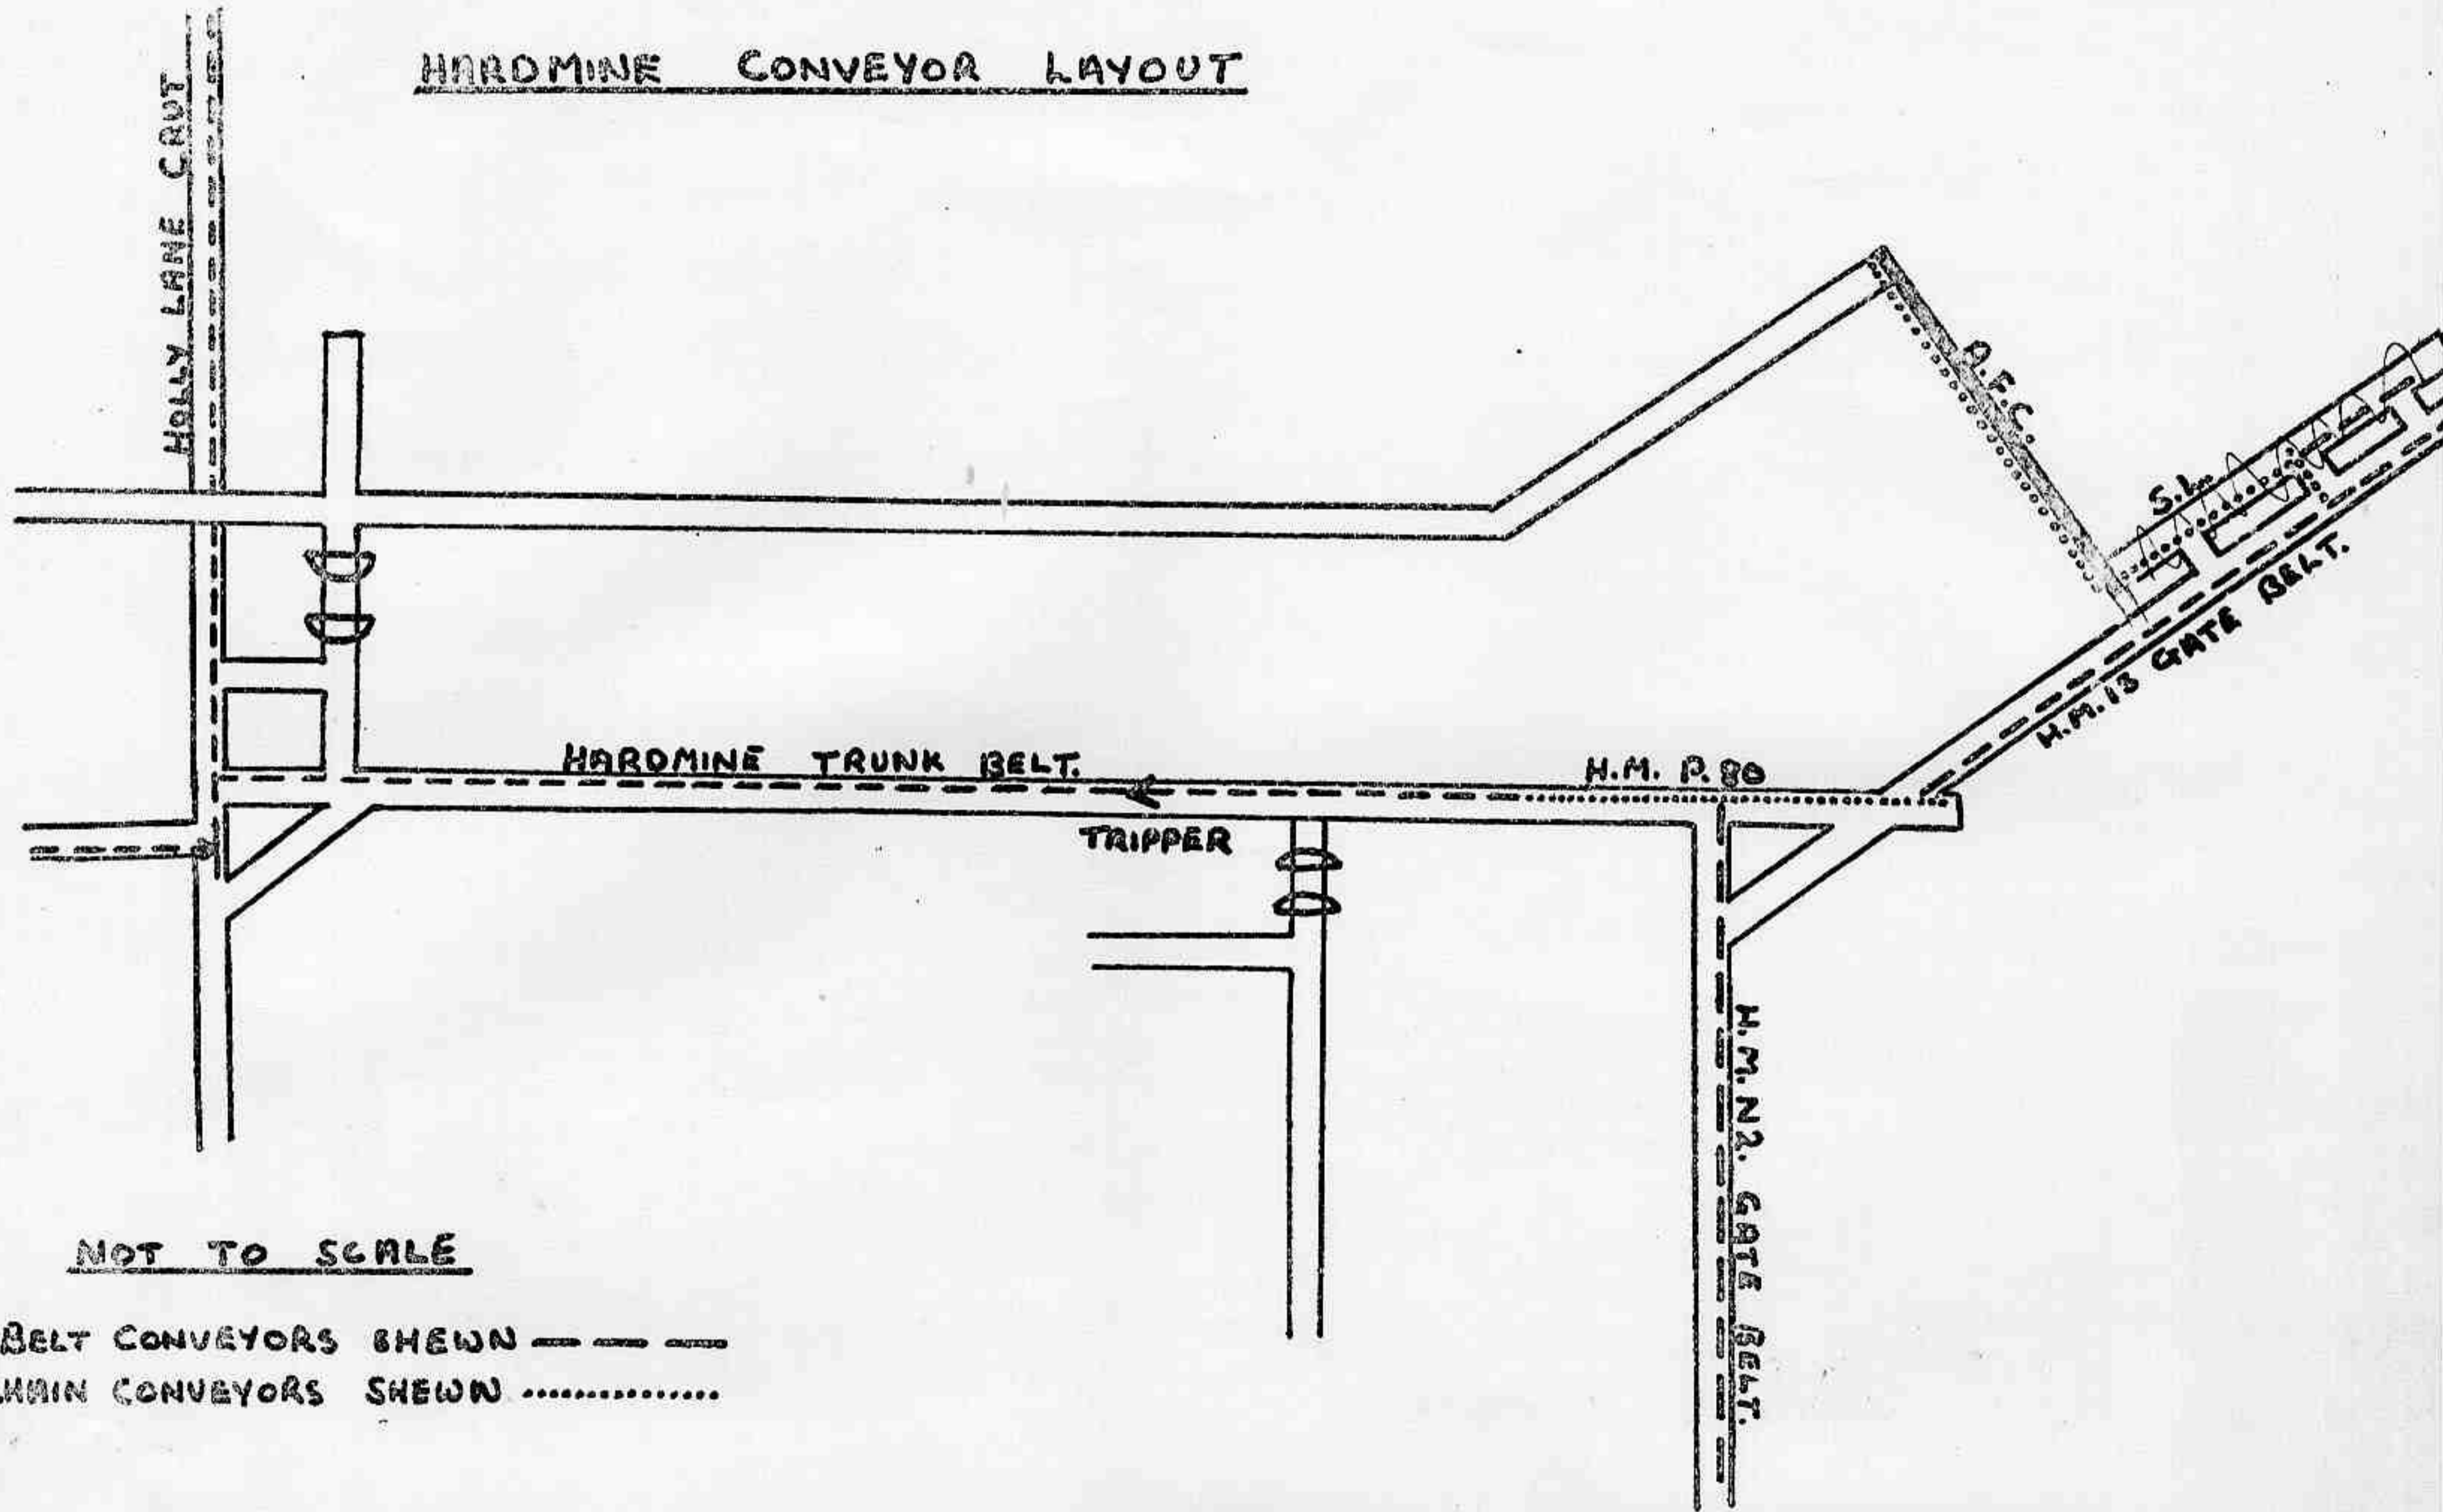
HARDMINE CONVEYOR LAYOUT

- 1/. Hardmine Trunk Belt; bottom strand ploughs at the "Tripper" and at the hopper end were badly worn and require replacing.
- 2/. The belt requires a bottom belt spray which would be most effective sighted 10 yards outbye of the "Tripper". COMPLETE ✓
- 3/. H.M.P.80 chain; this conveyor requires an effective chute at the delivery end.
- 4/. Hardmine 2's N gate belt; the delivery end of this conveyor requires an effective chute and cowl. SCREEN FILTER ✓
- 5/. Roadway consolidation of travelling roads. ✓

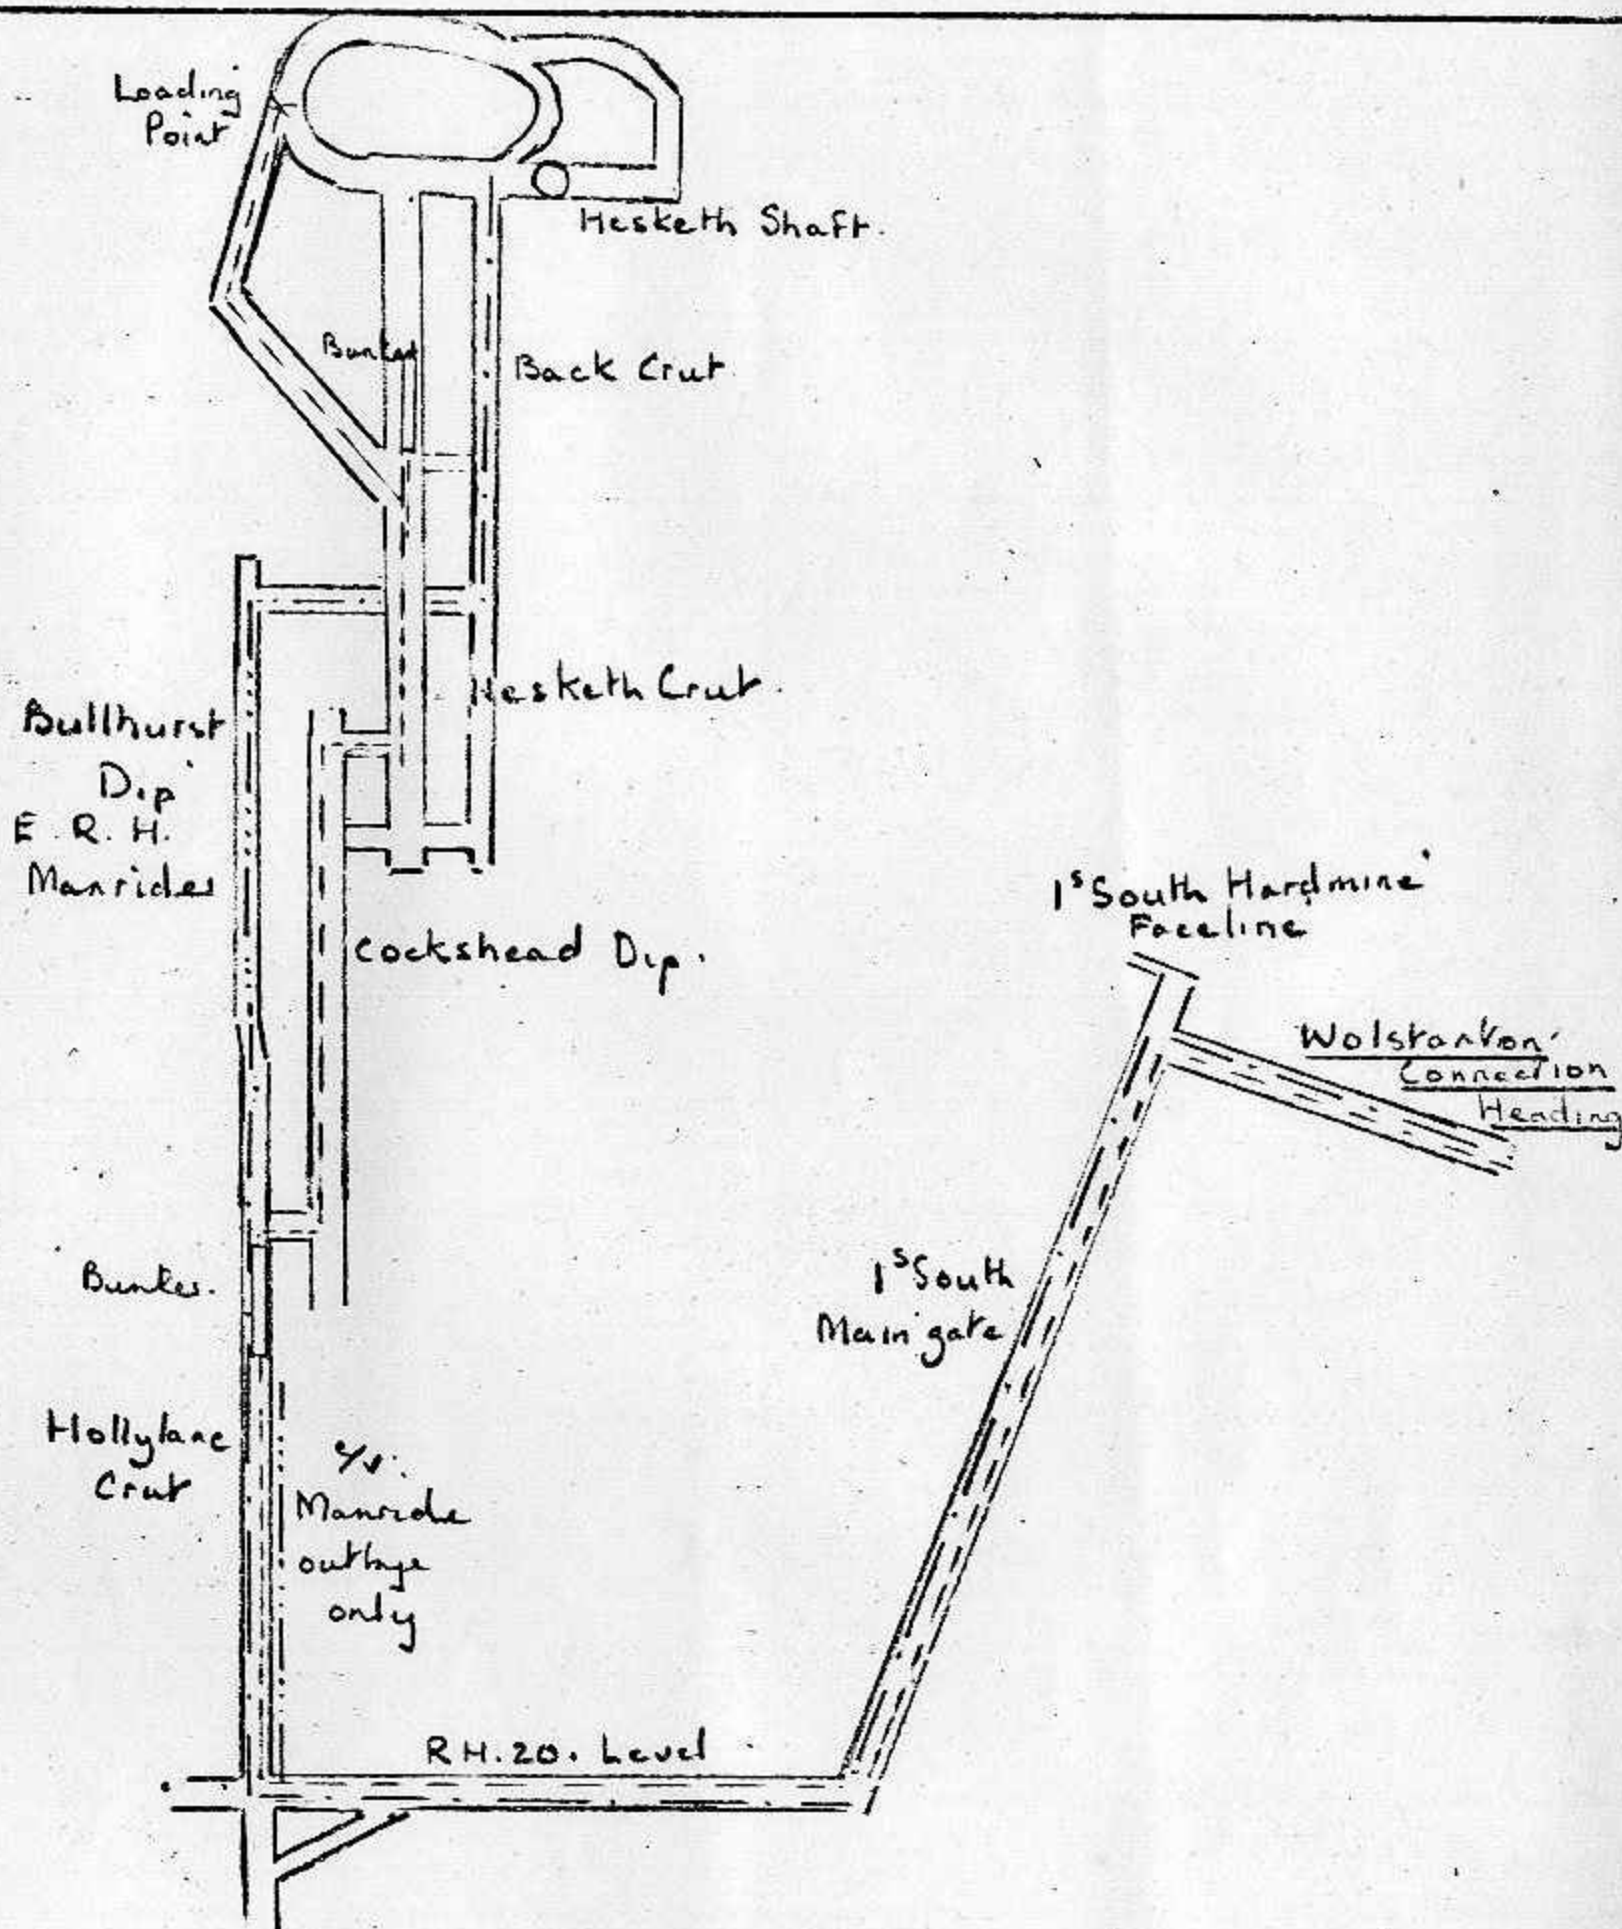
SKETCH PLAN.

Due to the low conditions and back ripping currently being carried out along 1's S Main Gate, the materials supply to the heading is disrupted and difficult.
