MEMORANDUM

Subject Chatterley Whitfield Colliery Date 24th May, 1961.
Encounter with water in the Middle Pit - Proving
borehole to Moss Seam.

Chatterley-Whitfield Colliery.

Encountered ~~Issue~~ of Water from the Moss Seam proving
borehole on No.1 North Yard Main Level in the Middle Pit.

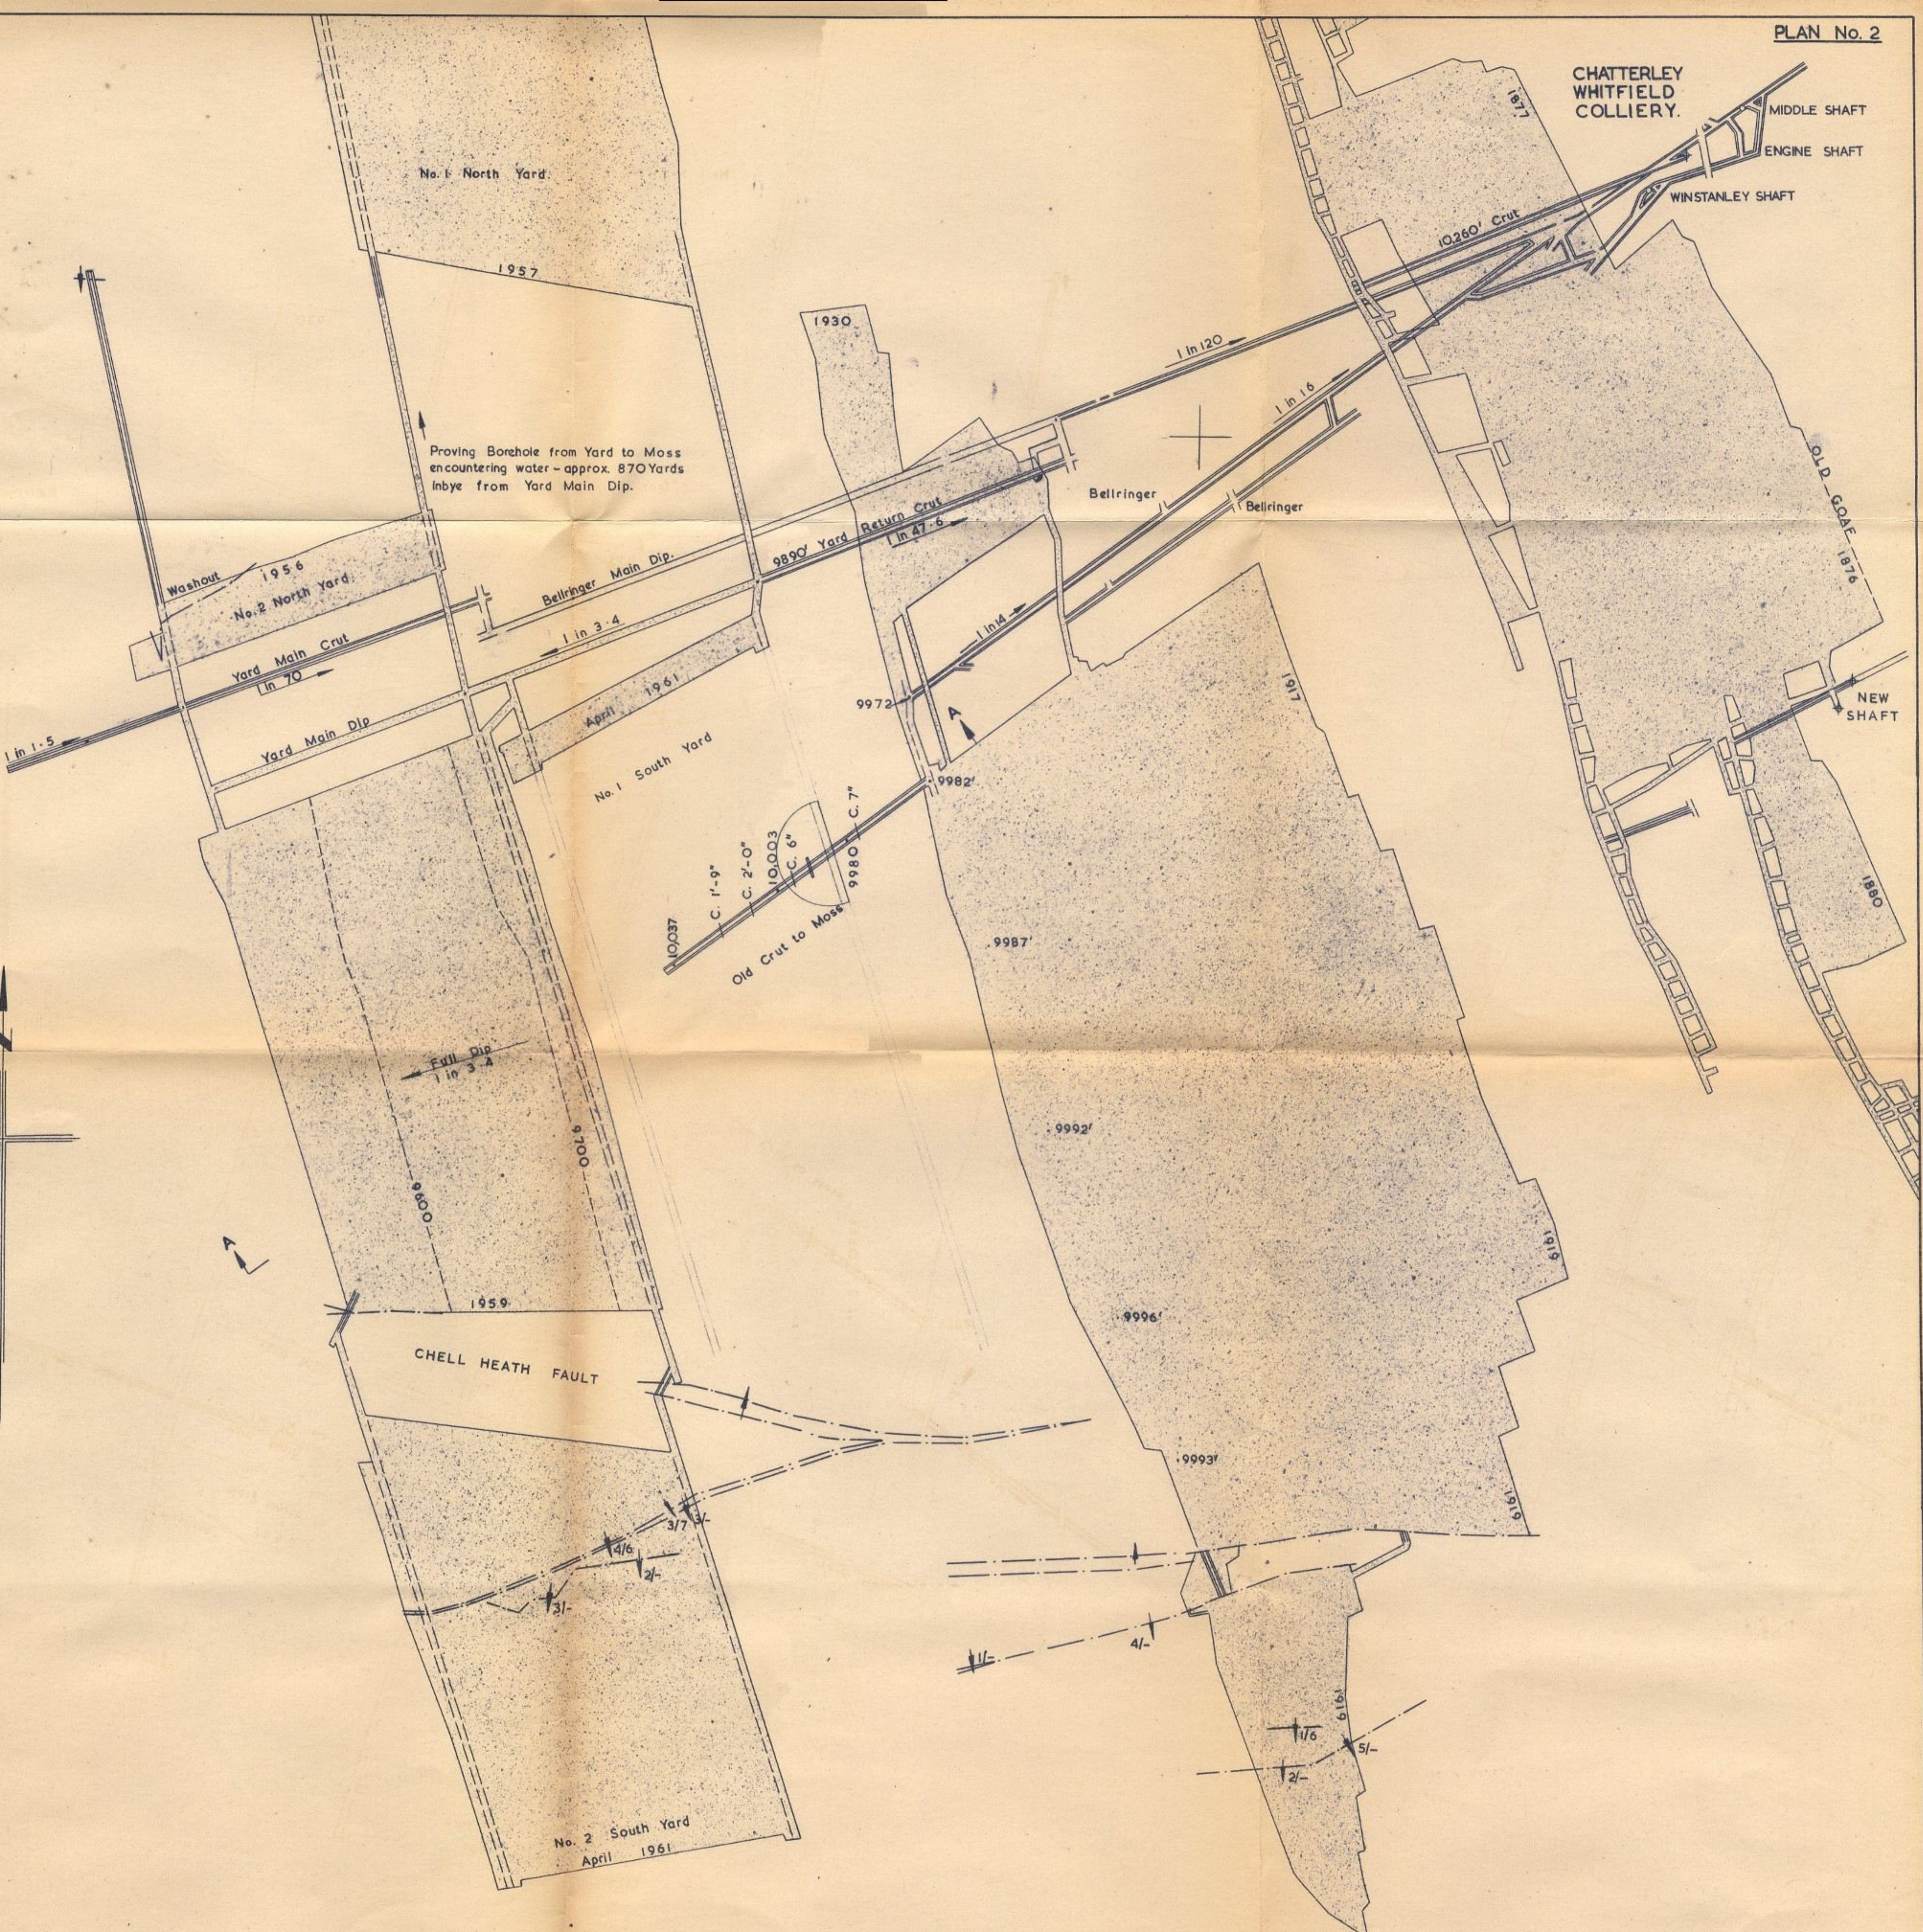
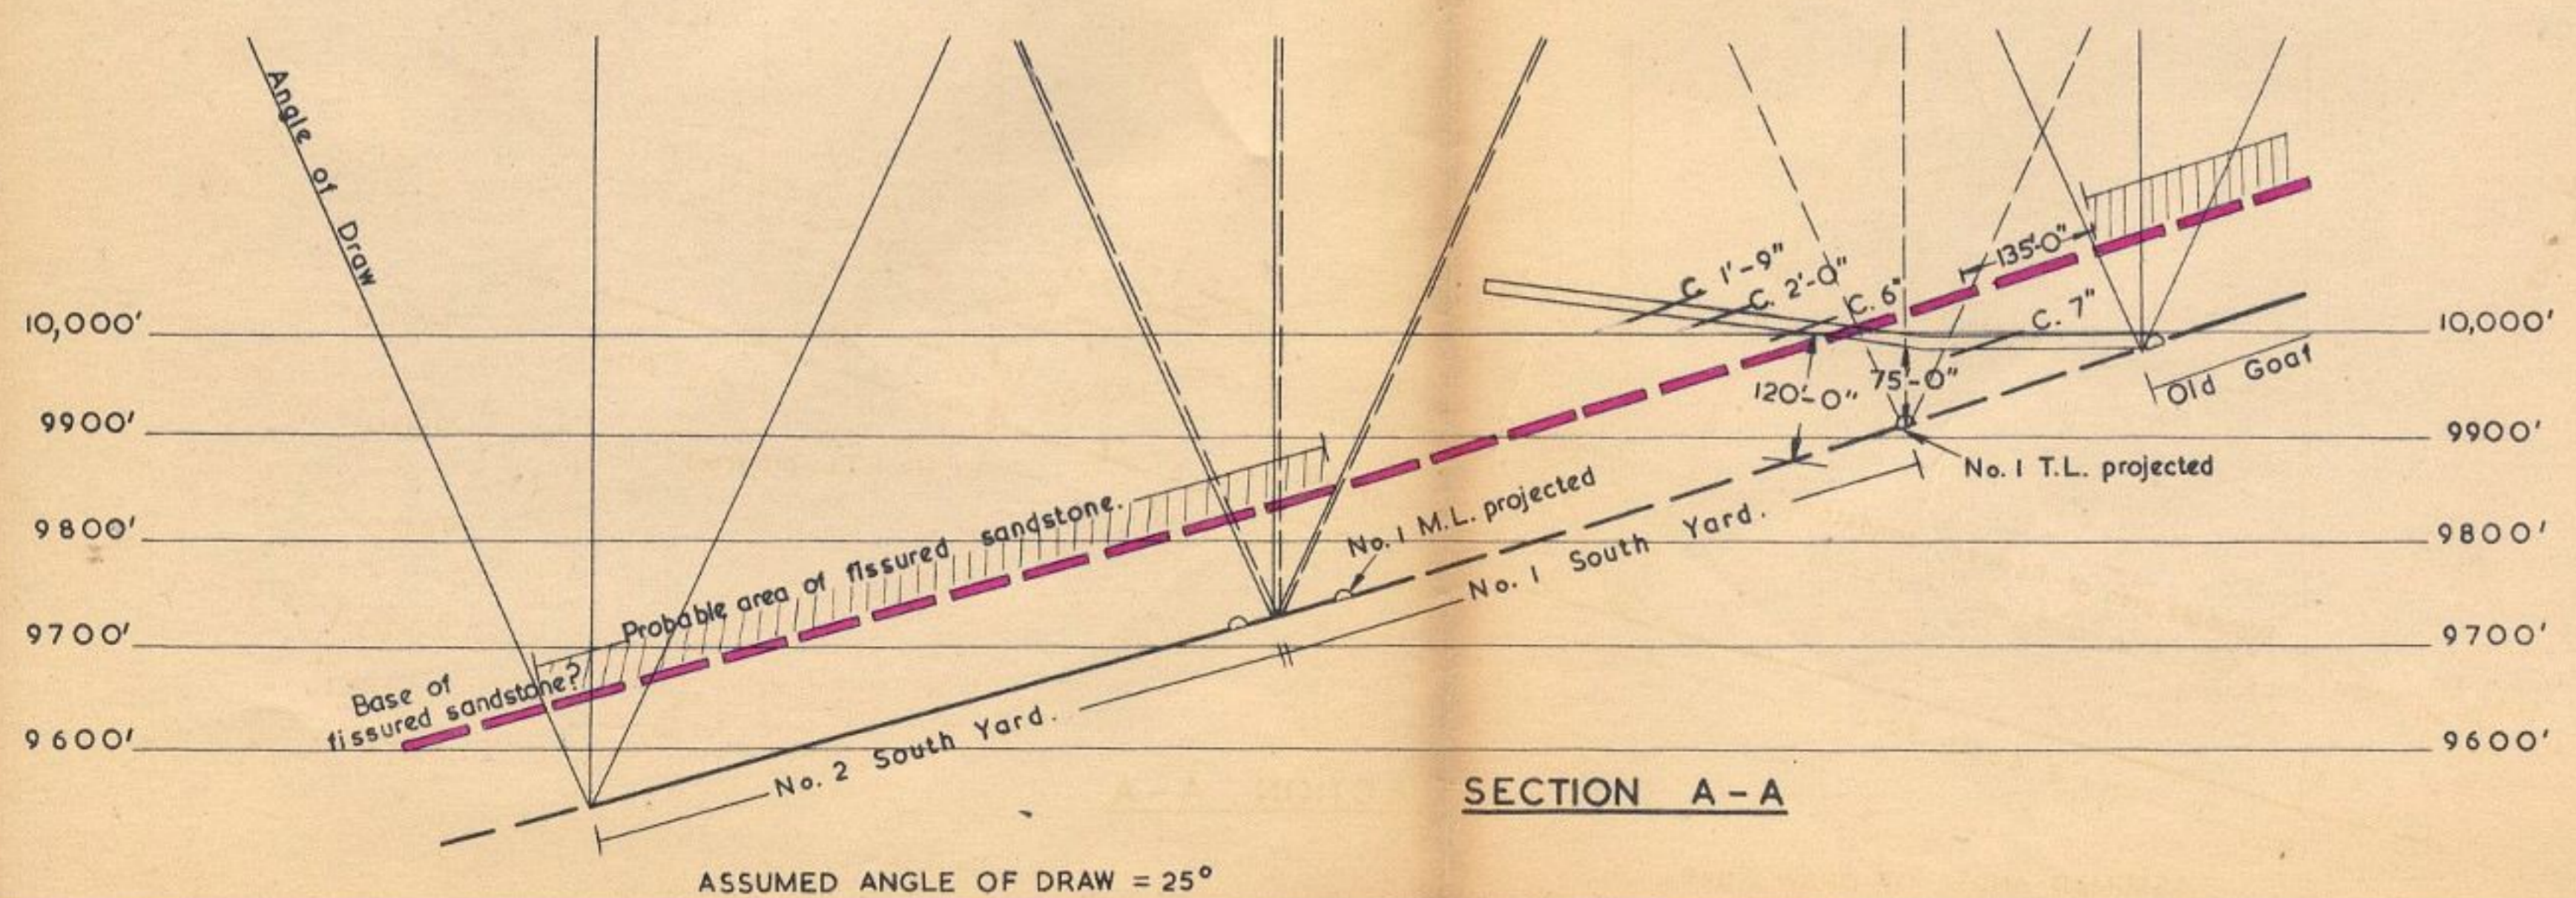
NATIONAL COAL BOARD			
WEST MIDLANDS DIVISION No. 1 NORTH STAFFS: AREA			
CHATTERLEY WHITFIELD COLLIERY			
Encounter with Water in Moss Proving Borehole from Yard.			
DRAWN BY TRACED BY CHECKED BY PASSED BY	A.A.L. W.E.	SCALE	AREA PLANNING OFF DRAWING No. 1681/50
		1/2500	
		DATE	
		May	1961

7. From the above mentioned No.1 North Yard, an exploratory borehole (Borehole X) was started in April 1961, to prove the Moss Seam. At a height of approximately 108 feet above the floor of the Yard Main Level, water was encountered on 19th April, 1961 in considerable quantity (approximately 100 gallons per minute) and pressure (200 lbs. per sq. inch rising to 225 lbs. per sq. inch). This pressure gives an apparent 'head' of approximately 500 feet, the level of the head being at or about 10260'. (refer item 2).

Apparent Head	Date	Pressure lbs/sq. ft.	Remarks
	19-4-61		Water encountered in borehole - estimated approx 100 g.p.m.
460	20-4-61	200	Flow of water from borehole controlled by valve - 1:30 am.
518	21-4-61		Drainage of water from borehole commenced
	23-4-61		
	25-4-61	225	
	26-4-61		Flow decreasing - valves cleaned out - flow as before
400	27-4-61	174	Drainage continuing
345	1-5-61	150	- do -
253	3-5-61	110	- do -

Water siphoned in 3" dia pipe to water lodge - to Bellringer Main Dip via No. 2 N. Yard Main level, Main Dip & Return Crut.

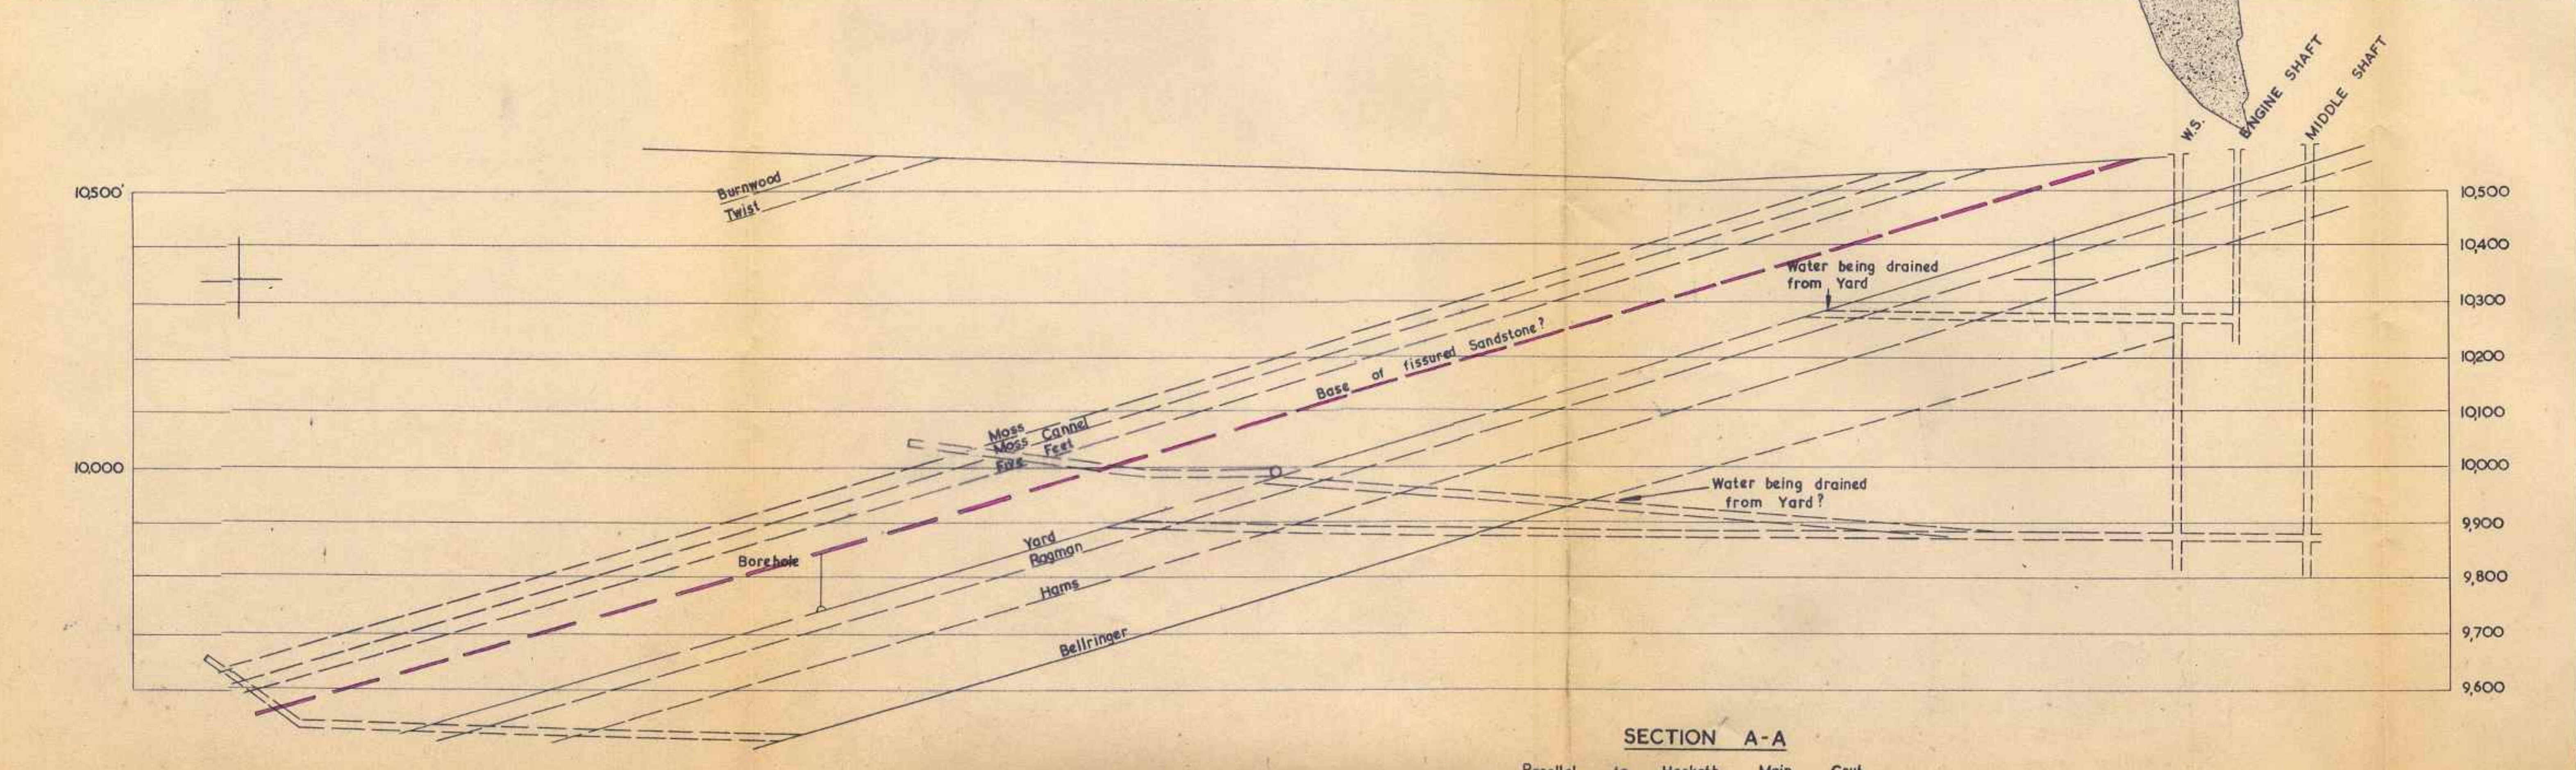
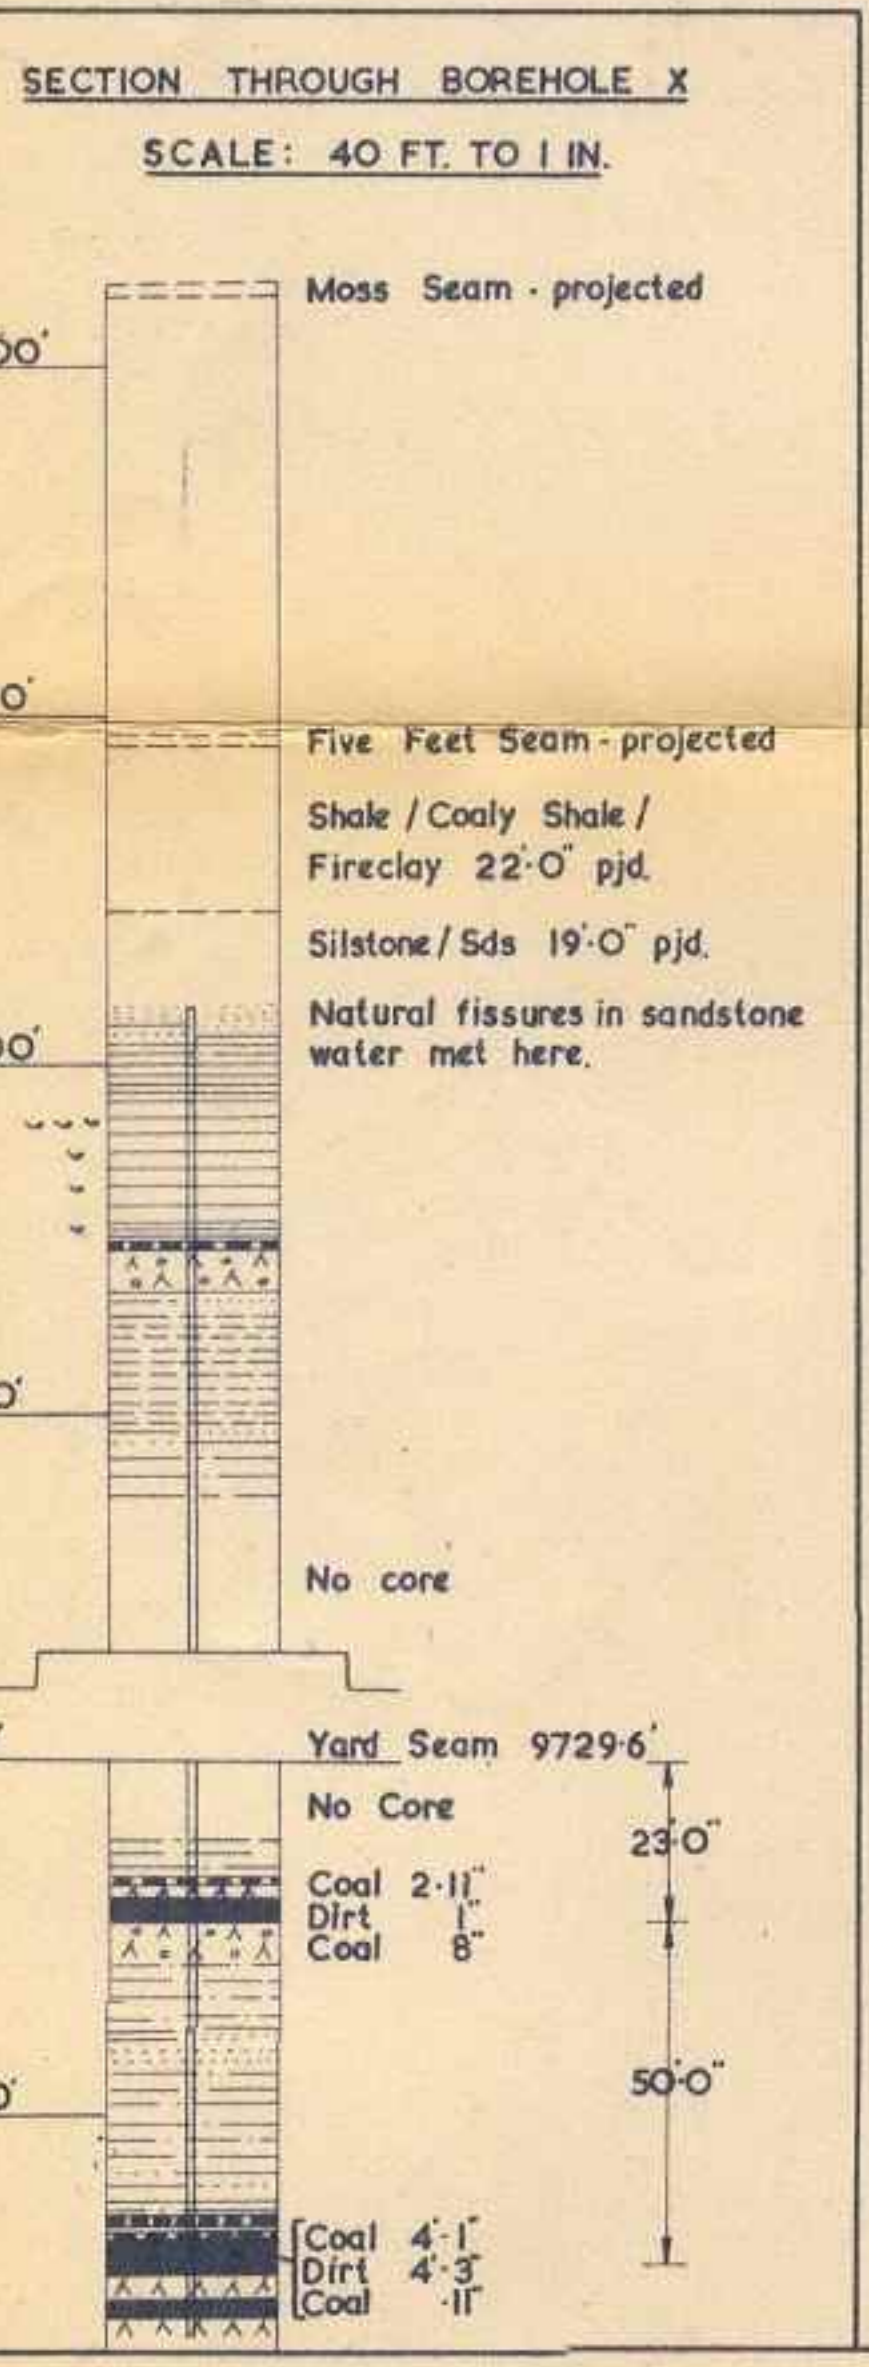
NATIONAL COAL BOARD
WEST MIDLANDS DIVISION No. 1 NORTH STAFFS: AREA
CHATTERLEY WHITFIELD COLLIERY
Encounter With Water In Moss Proving Borehole From Yard.

From the old working plans it is apparent that this second development of the Yard Seam took place to the rise and approached to approximately 140 yards from the deepside of the 1870/80 goaf worked from the 10,260' Crut.

5. In the early life of the second development a crut was driven from the old Yard Main Level at 9982' to prove the Moss Seam. History related that this crut met with a considerable amount of water during the drivage. Some confirmation of this appears in the plotting, from old spot levels of a section along the line of this crut. It appears that the crut was driven approximately level for 75 yards, followed by a rise of 1 in 7 for 55 yards, flattening to a rise of 1 in 8 for 90 yards.

18. No.1 South Yard Panel. This panel may well be the first panel in the Yard seam at Chatterley to be worked between two panels of goaf. I suggest that the top rise side goaf may have affected the sandstone above, and that a considerable water pressure may be in existence. The goaf lying to the deepside may have caused the overlying sandstone to become receptive for the holding of water in large quantities, but until the No.1 South panel has bridged the apparent gap between the two goaf areas and allowed the water to drain through, no water may be encountered.

A further complication to the working of this panel may be experienced in the close proximity of the old proving crut to the Moss, which passes approximately 75 feet above the top level and overlies the panel. Considerable water pressures may be in evidence.
