NATIONAL COAL BOARD

COLLIERY *Chatterley Whitfield*

Face Delay Study. 3rd South Moss.

Report on Face Delay Study on 3's South Moss Chatterley/WhitfieldReference 310/8/661. INTRODUCTION

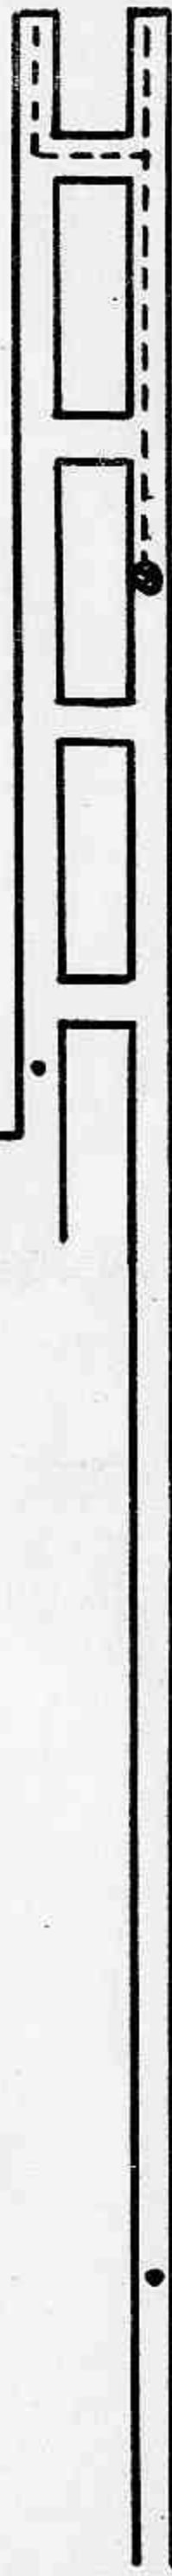
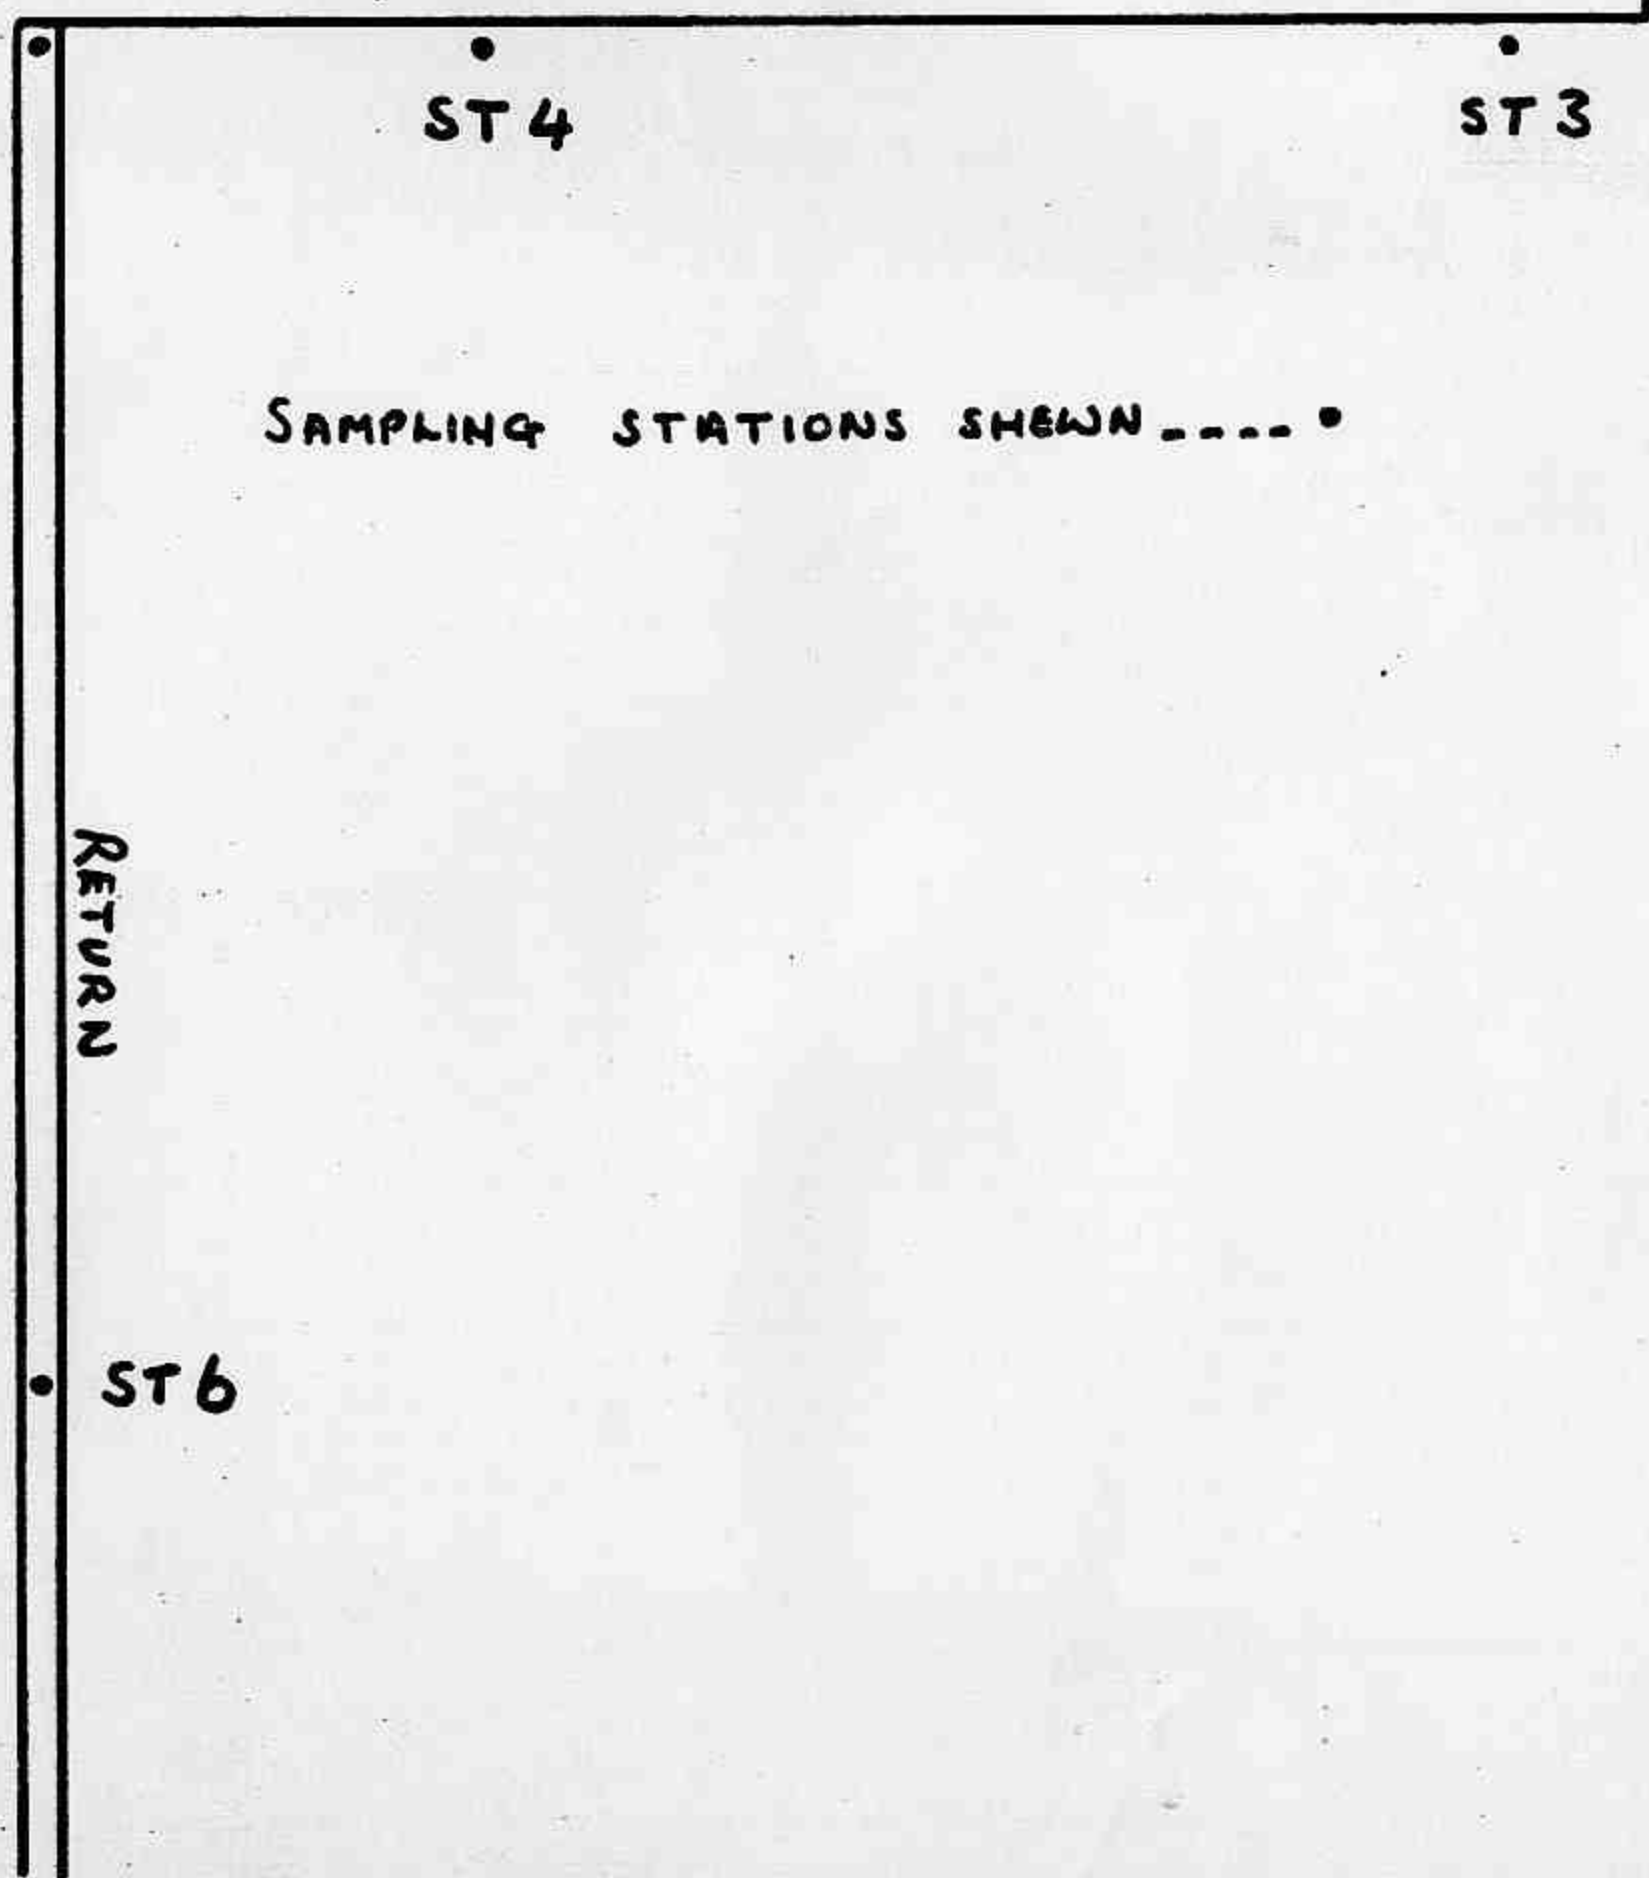
AIRBOURNE DUST SURVEY

DATE	DUST CONCENTRATIONS Mg/m ³					
	ST 1	ST 2	ST 3	ST 4	ST 5	ST 6
22/10/73	5.1	6.8	5.2	8.4	10.6	12.7
23/10/73	3.3	4.5	5.4	14.6	13.7	12.3
24/10/73	3.6	8.8	6.9	11.4	9.4	10.6
25/10/73	4.1	7.0	6.1	12.5	13.4	13.3
26/10/73	4.4	5.5	5.2	10.7	15.0	14.9
AVERAGE	4.1	6.5	5.8	11.5	12.4	12.8

The average dust concentration at the 70 metre mark in the intake is 4.1 mg/m³.

The two headings in front of the face at the intake end, contribute about 3 mg/m³ of dust so that the air starting up the face has a dust load of 6.7 mg/m³.

The main shearer which is automatically steered and the other operations along that length of face contribute about 5 mg/m³.

There is a further pick up of about 1 to 2 mg/m³ from the main machine finishing point out to the 70 metre point in the return airway.

Action should be taken to reduce the intake pollution from 4.1 mg/m³ to 2 mg/m³. The methods are outlined in a document already in the hands of the Colliery Dust Suppression Officer.

The ventilation system for the two advanced headings has no filter system and immediate improvement can be obtained by placing a Joy Microdyne free standing filter over the stage loader adjacent to the face. There should be at least 8 to 10,000 c.f.m. of air filtered to improve the face intake to below 3 mg/m³.

The shearer should have a new drum with wider pick spacing and the facility for a hollow shaft ventilator.
