NATIONAL COAL BOARD

Face Delay Study. 3rd South Moss.

Report No. *310/3/66*

*Mr W. Stephens*DUST SUPPRESSION DEPARTMENTCHATTERLEY WHITFIELD COLLIERY - 1's SOUTH HARDMINEINTRODUCTION:

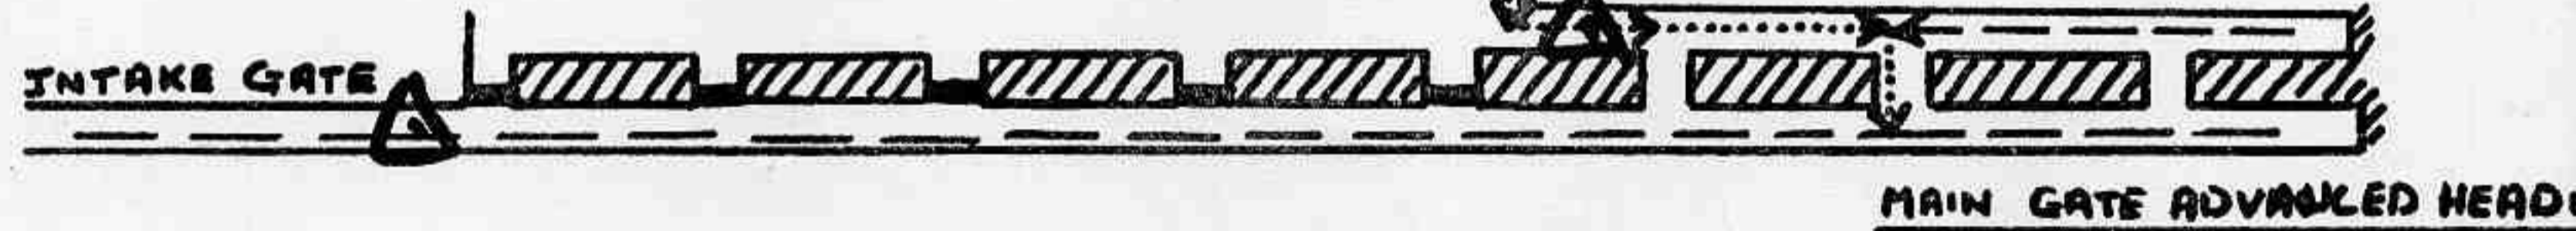
HARDMINE 1st SOUTH GENERAL LAYOUT

The samples taken at Stations 1, 2 and 5 were over the full shift and give a comparison of the effect on the whole district. Samples taken at Stations 3 and 4 were taken only during the time that the machine was shearing to measure the effect of improved horizon control on the dust conditions produced.

SHOWING DUST SAMPLING POSITIONS.
